The recent flooding across Queensland, Northern NSW and Western Victoria has caused loss of life and immense damage to properties. Understanding where to start in the rebuilding or reconstruction process can be difficult. As people now start to assess the damage to their homes, CSR appreciates the situation they may be in and in order to assist the process this bulletin will aim to provide corrective measures and relevant information relating to products which may have been affected. Your safety and understanding of what to do is our priority and this recommendation is based on dealing with plasterboard, fibre cement, insulation, glass, bricks and roofing products.

Before the work begins – things to consider...

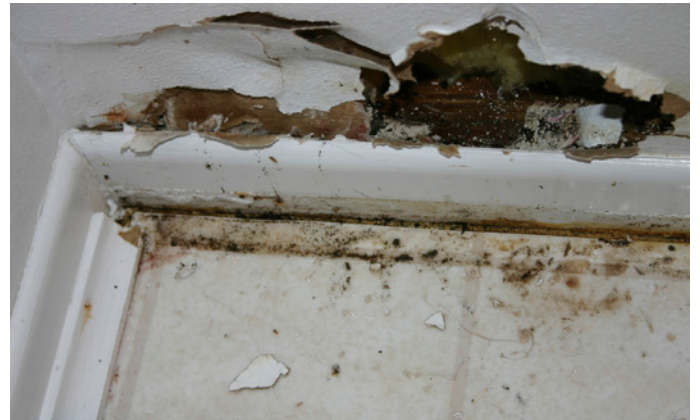
- Where flood water has risen up walls, it is important to drain any water from the cavities. Skirting boards need to be removed and holes drilled above the bottom plate, or if you have metal stud walls then they are removed by drilling through the channel at floor level. If water is present in the cavities then cut a hole which is large enough to drain the water. To ensure all water is completely drained, this process must be repeated at each cavity. If the wall cavity has insulation material in it and this is wet, then the lining on at least one side of the wall will need to be removed to take the wet insulation out.

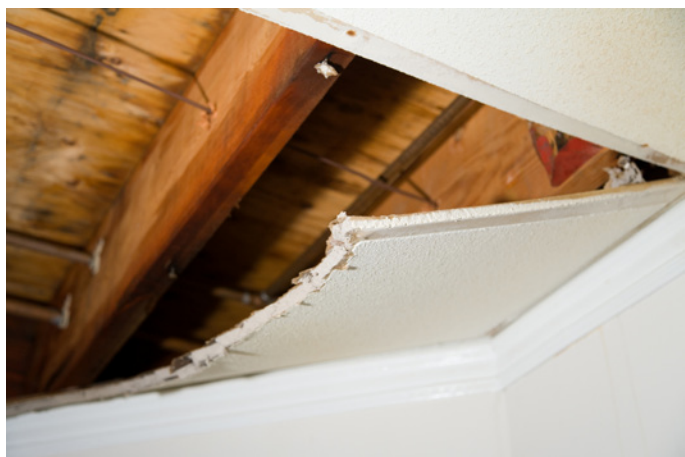
- Almost all ceilings that have been inundated will need to be replaced (especially where absorbent insulation is involved) as water will likely have ponded for too long a period and all the fixings will be compromised.

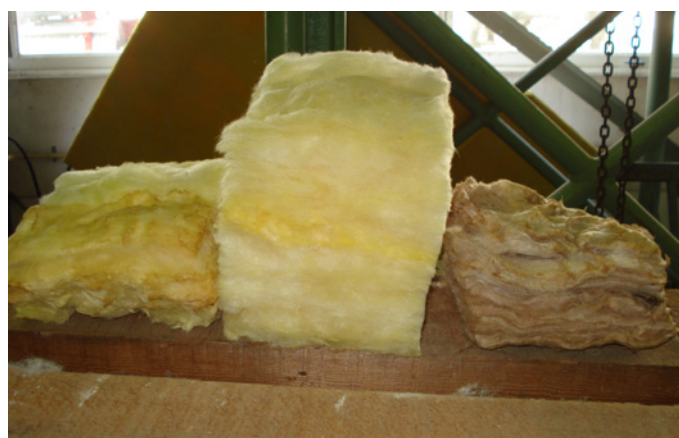
- If the insulation has been completely saturated then it will be required to be replaced. If the insulation has been completely saturated and then dried out, it may not recover to its original thickness and its thermal performance will be significantly reduced.
- On the other hand if the insulation is only slightly wet due to something like minor leakage through the roof and then it can be removed, dried out and reused.
